SOYUZ

investigation lands with a thud

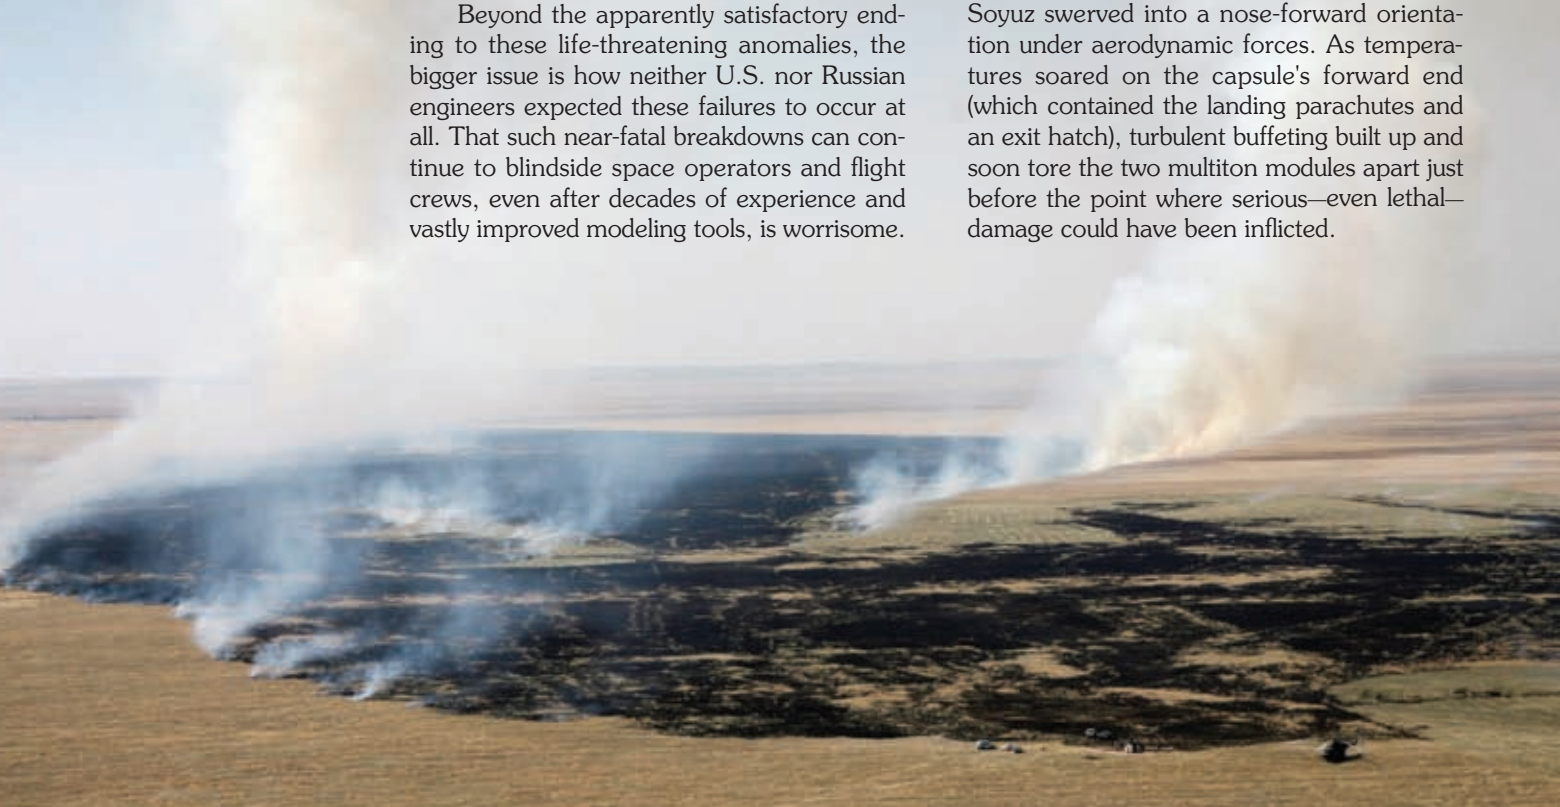
The Soyuz TMA-11 spacecraft (opposite page, lower right corner) lands next to a burning field April 19, 2008, in central Kazakhstan carrying NASA astronaut Peggy Whitson, Expedition 16 commander; Russian Federal Space Agency cosmonaut Yuri Malenchenko, flight engineer and Soyuz commander; and South Korean spaceflight participant So-yeon Yi. Photo: NASA/Reuters/Pool.

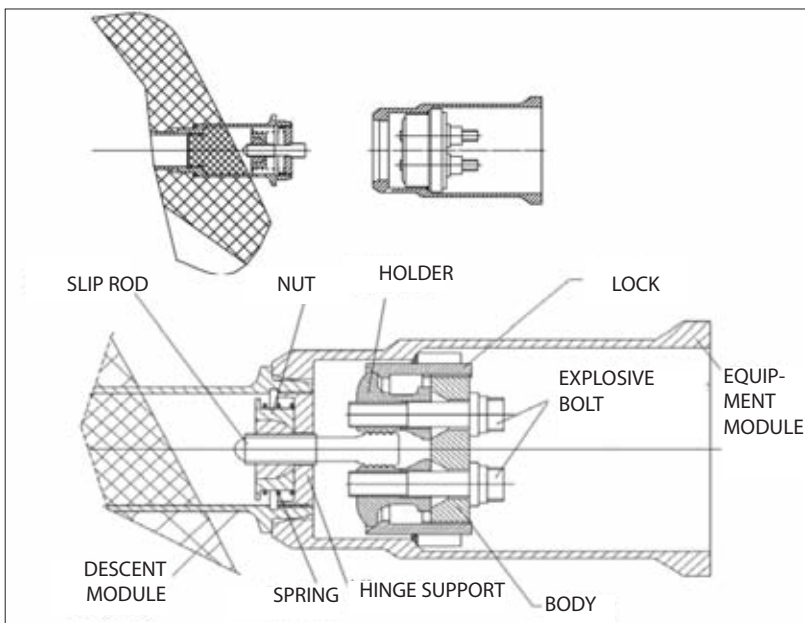
A cross-section of a separation bolt shows how firing of either of two independent pyrobolts would free the module attach bolt. On two successive Soyuz landings both pyrobolts at one of five attach points failed to fire. A Russian investigation concluded that in both incidents, both bolts in one pair were rendered defective by electrostatic charges.

The two bolts that failed were in the same position around the waist of the Soyuz and, because of the coincidental overlay of an aerodynamic shroud attach point, were not only isolated but also grounded differently (and apparently inadequately) from the other four pyrobolts. The fabrication of the pyrobolt support structure was modified, and command cables were rerouted, with increased EMI shielding, for the Soyuz launched in October 2008. When it returned to Earth early in April it landed safely and smoothly.

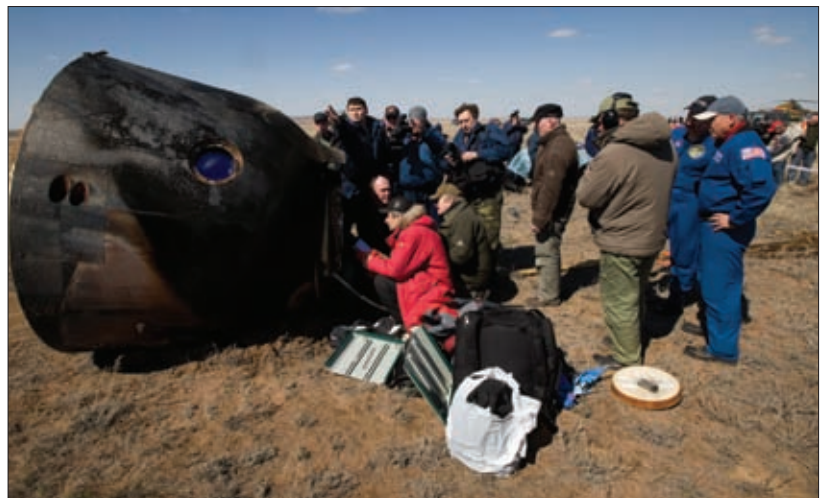
Russian search and rescue forces and medical personnel assist the crew of the Soyuz TMA-13 (which had the safety modifications) after its safe landing on April 8, 2009. Photo credit NASA/Bill Ingalls.
