SOYUZ

investigation lands with a thud

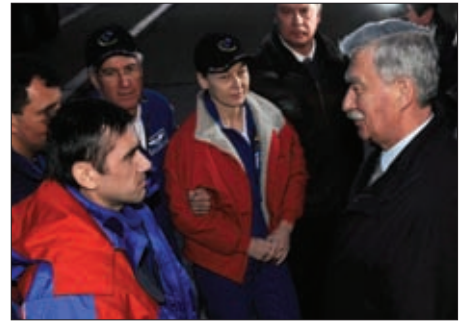
Russian officials welcome astronaut Peggy Whitson, cosmonaut Yuri Malenchenko, and South Korean spaceflight participant So-yeon Yi (out of frame) at the Chkalovsky airport, Star City, after their bumpy ride home aboard TMA-11. Photo Credit: NASA/Bill Ingalls.

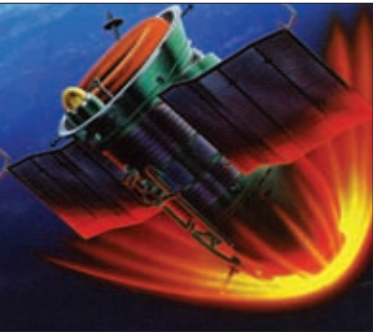
On entry, the first Soyuz in 1969 separated safely only after smoke filled the cosmonaut cabin; recent events closely resembled this.
